[Home](#) > My rotor is leaking around the riser stem, is there something I can replace or repair to fix this?

Products: [PGP-ADJ](#), ^[1][PGP Ultra](#) ^[2]

Replacing the Riser Seal on a Hunter rotor

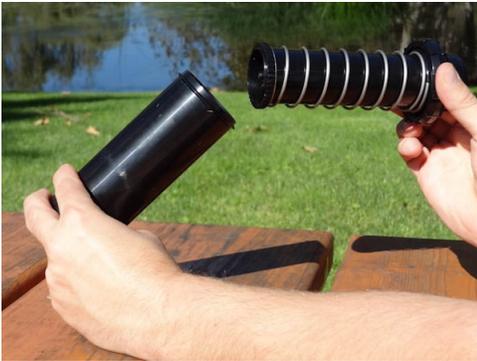
STEP ONE

Unthread the body cap and remove the internal assembly from the pop-up body.

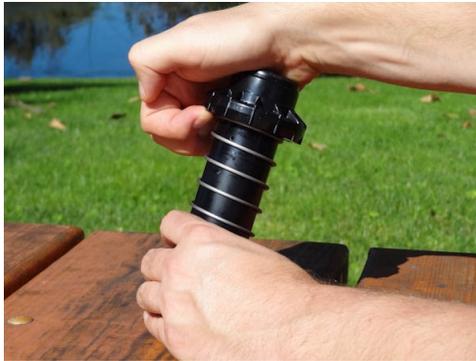
STEP TWO

Place the base of the riser on a solid surface and grip the spring and riser body firmly. With the other hand, snap off the body cap—with your palm on top of the logo cap, pull up with your fingers.

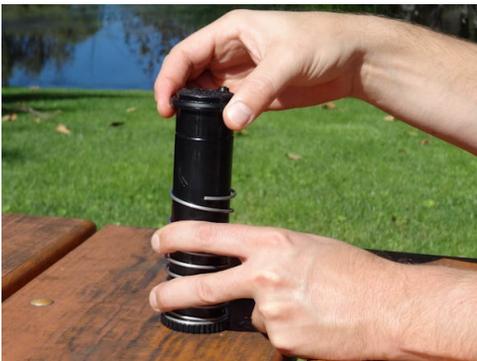
STEP THREE

While still gripping the spring and body, remove the rubber seal.

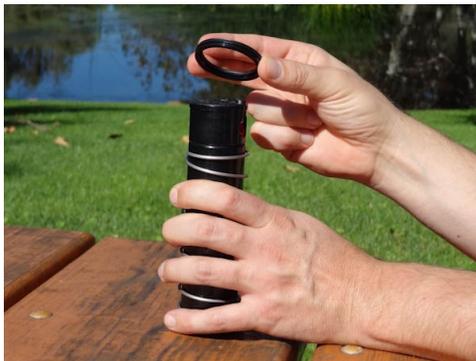
STEP FOUR

When you remove the seal, the spring's tension will be released. Remove the plastic

spring and plastic springseat (if it was not pushed off by the spring).

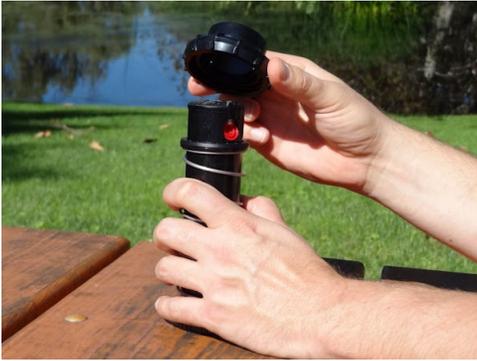
STEP FIVE

Now that the old seal is removed, the new seals and plastic spring seat can slide over the top of the rotor's turret and onto the riser. Be sure to install the spring seat prior to the riser seal. After the new components are installed you can then reinstall the rotors body cap.
