Dell Corporate Campus, Austin, TX
Estados Unidos

Neighboring Development Drops Water Pressure

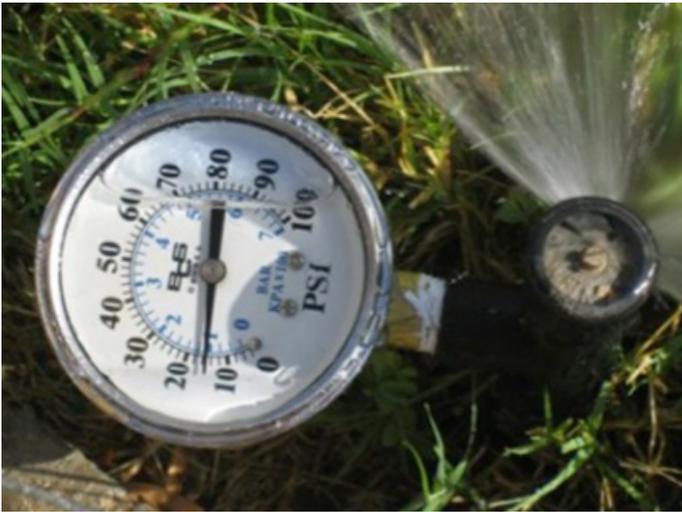
[1]

Because of this change in pressure, the traditional nozzles that most pop up sprinklers use aren't able to correctly distribute water, and both the health and the appearance of areas needing irrigation become adversely affected. Dell's case was no different, and after a sustained period of being irrigated with the wrong water pressure, grass, trees, and flower plants all over the grounds began to brown and wither to an alarming degree.

While operating with traditional spray nozzles, the system was found to have a pressure of 1 bar, which is well below the ideal operating pressure of 2 bar. After installing MP Rotators, the system was found to be operating at just below 3.4 bar, which allowed the water to reach all of the areas it was designed to reach, and also dispersed the water more evenly throughout the soil. With MP Rotators now installed wherever appropriate throughout the grounds, Dell's campus has returned to its status as one of the most beautiful, prestigious such complexes in the world.

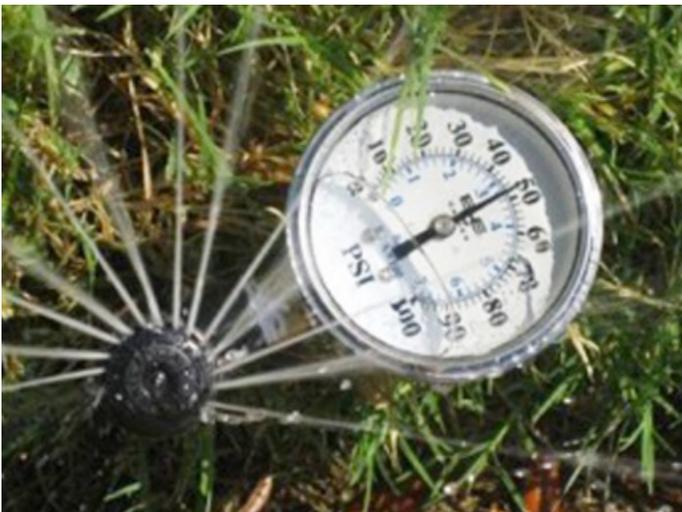
[2]

One lawn area on the campus looked particularly bad because of the looming low-pressure problem. Water was not reaching all of the grass it was supposed to, because the traditional nozzles simply couldn't push it far enough. Hunter's MP Rotators are designed to create proper water distribution even with low-pressure situations, because they disperse water in a slower, more unified fashion. This particular instance at Dell seemed like a great opportunity to test the MP's low-pressure performance in comparison to traditional nozzles. To perform the comparison, the particularly bad area was tested for operating pressure and then retrofitted with MP Rotators, and re-tested. After a sustained period of use with MP Rotators, the appearance and health of the landscape before and after the retrofit was also observed.

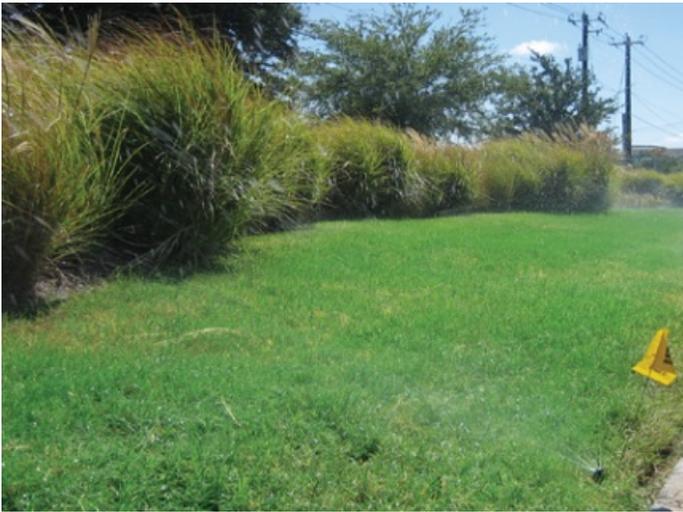
[3]

The MP Rotator is a revolutionary sprinkler setting a new standard for water efficiency in the turf and landscape industry. Multiple rotating streams provide superior uniformity; automatic matched precipitation even after arc & radius adjustment, low precipitation rate reduces runoff on slopes and tight soils. Rotator Technology proven in demanding agricultural conditions since 1987, one moving part, "double-pop" flushes on star-up and shutdown.
