Palm Springs, California, United States

MP Rotator Uniformity – Canyon Estates HOA Palm Springs, CA

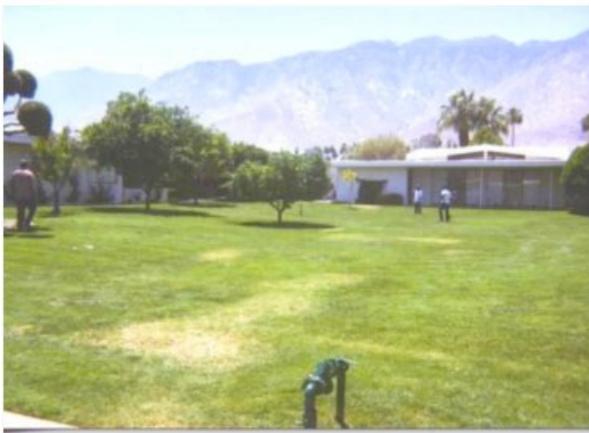
After a look at the overall system, Hunter professionals noticed that it had an inefficient pipeline, which was causing low-pressure conditions. This low pressure meant that the traditional spray nozzles in the system were no longer able to cover the entire areas that needed irrigation. Most system operators would try to solve this issue by simply increasing the run time of the system until the brown spots disappear. However, while this solution may improve the look of the site, it results in a tremendous increase in water consumption, which is both costly and environmentally unfriendly. Hunter Industries professionals decided that the MP Rotator would be a better option, because the MP Rotator has much lower flow rates than traditional spray nozzles, which means not as much water pressure is needed to properly irrigate. To see if MP Rotators were right for this job, a particularly brown span of grass was retrofitted with over 70 new High Efficiency MP's and systematically tested.

Initial Site

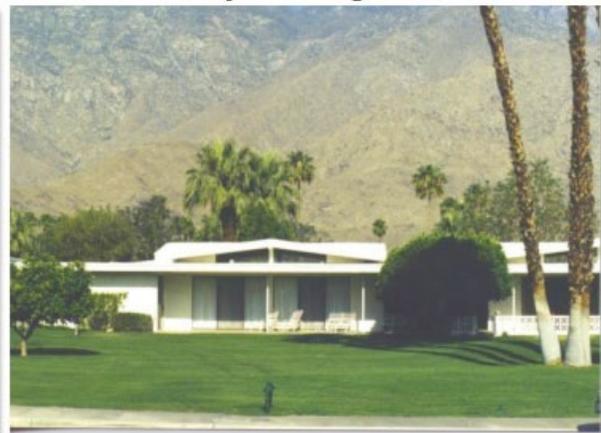
After just 10 days of operating with the High Efficiency MP's, the lawn's appearance in the tested area was much different. It was as though a whole new layer of sod had been installed, as it was lush, green, and free of brown spots. The best part about it? Not only did the MP Rotators resurrect this long-neglected site, it did so using less water than the original nozzles.

After 10 Days of using MP Rotators
